Planet Carrier Spline Repairs

EQUIPMENT: CAT TRUCK

TO SUIT MACHINE: 785 & 789

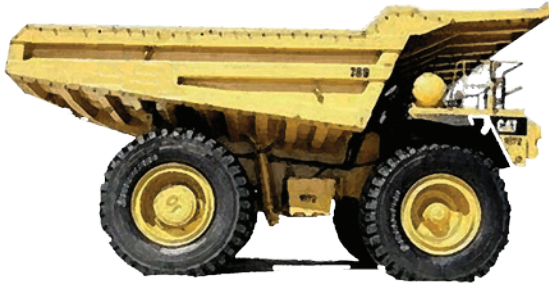
Repair process flow illustration

1 Worn internal spline removed and internal spline cut out

2 Spline insert manufactured

3 Insert is fitted to modified carrier and retaining keys are screwed into place

4 Sectioned view of assembled carrier repair

5 Completed repair with new spline and retainer keys

Instead of buying a new Planetary Carrier for your CAT 789, Geographe have developed a repair procedure where the existing carrier is re-worked (figure 1) by cutting the spline and manufacturing a new spline that simply gets changed out after wear.
